## **CHAPTER 3**

# **ENVIRONMENTAL BASELINE STATUS: PHYSICAL ASPECTS**

### **3.2 DIBANG CATCHMENT**

Dibang Multipurpose Project is located on river Dibang. The river originates from the snow covered southern flank of the Himalayas / Trans Himalayas

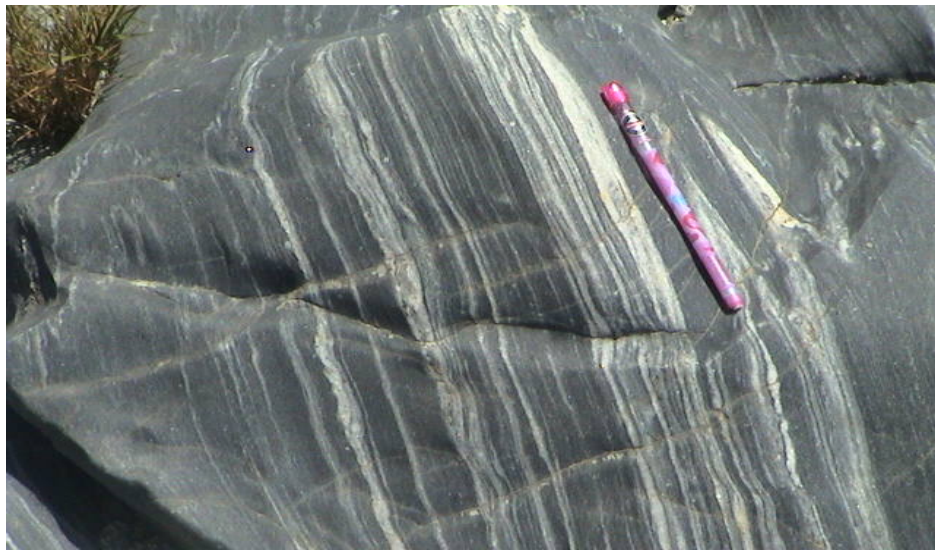
**Photo 3.1: Feldspathic biotite gneiss outcrop on the left bank near cane-bridge, downstream of the confluence of Ichi nala with Dibang**

schist and graphite schist shows well developed schistosity. At the confluence of the Ahi river with Dibang, the quartz chlorite schist rocks gradually grades into feldspathic gneiss rocks showing steep dips (**Photo 3.1**). At the Ichi nala confluence feldspathic gneiss rock is exposed.

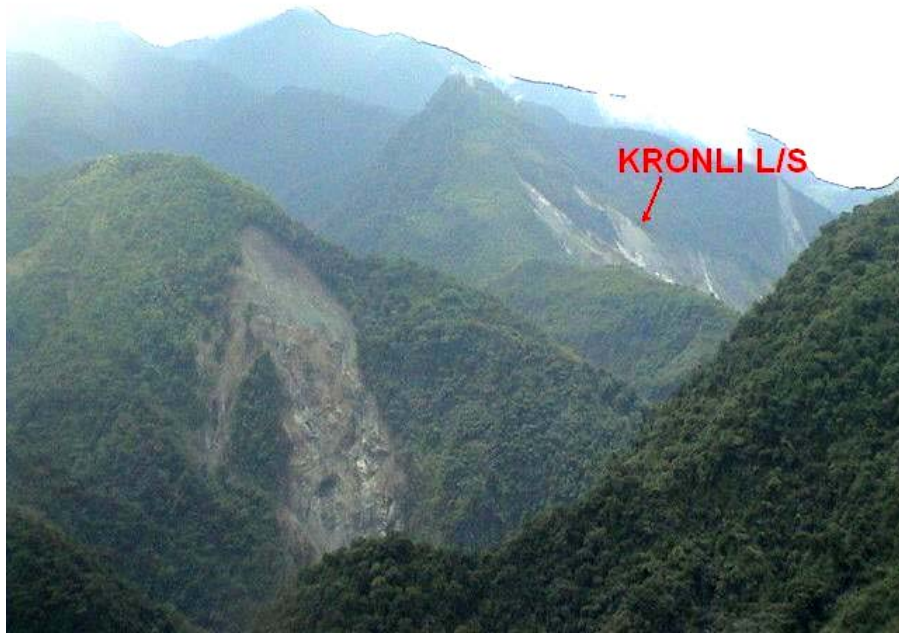
**Photo 3.3: Active landslide zone (more than 1.5 km in extent) downstream of Kronli in the rocks of Hunli Formation**

Other major landslide zone is present on left bank of Dibang downstream of Kronli village and is identified L-51 (**Photo: 3.3**). This massive landslide extends for about 900 m from river bed up to its crown and has a lateral extent of about 800m at the base. This area marks highly disturb zone and anticipated to be associated with tectonic lineament as evident by highly crushed and sheared mica chlorite schist and gneissic rocks of Hunli formation present in this area. Several steeply to moderately sloping scarp faces are exposed along the slide. This slide zone is highly active especially during the monsoon season when surface runoff and seepage is enormous. The frequency of sliding has enhanced during the last 15 years due to which entire Kronli village has been evacuated and resettled at Ardzo.

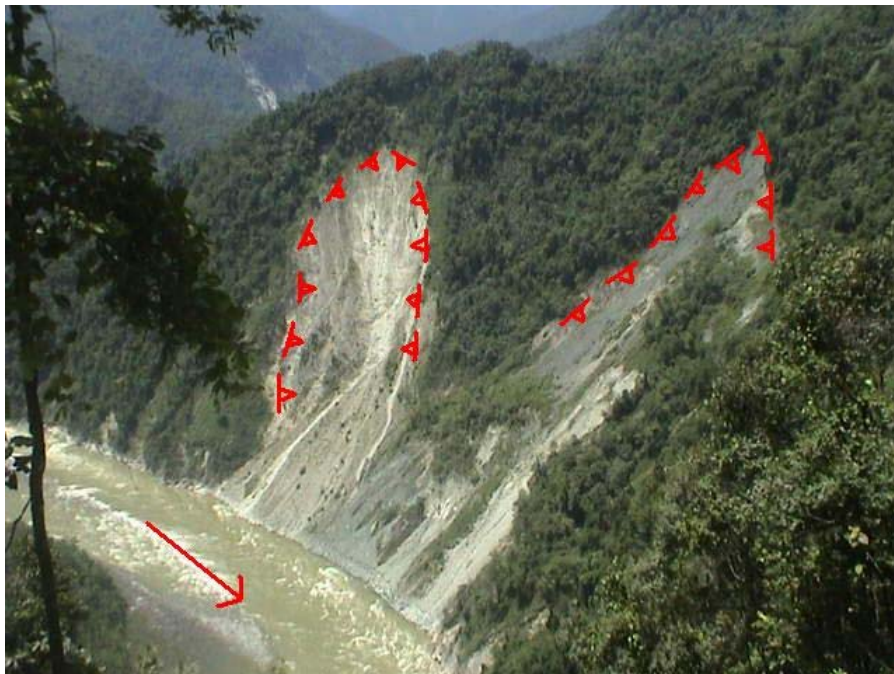
**Photo 3.5: Landslides on left bank of Dibang about 1.2 km downstream of Enne nala. High rate of toe erosion and failure along weak planes has made this slide active**
